## EVEN HARMONIC RESONANCE- AN UNUSUAL PROBLEM

Copyright Material IEEE Paper No. PCIC 2002-11

**Abstract** - The paper is a case study examining the cause, effect and solution of an actual "non-characteristic" even harmonic problem in an electrochemical plant. While issues concerning "characteristic" harmonics are well documented in the literature, limited information is available describing how non-characteristic harmonic currents create operational problems. The author has not found any papers describing a case of even harmonic resonance and would like to share the experience of resolving a 4<sup>th</sup> harmonic resonance problem in the hopes it will benefit others.

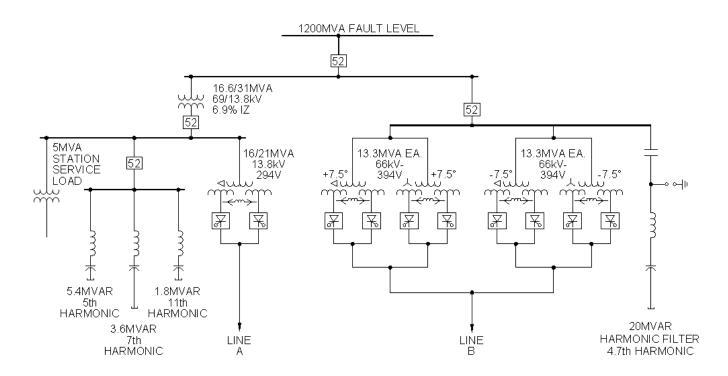
Fig. 2: Electrical Single Line Drawing Showing Main Power Distribution

The Line B rectifier system is supplied directly at 66 kV, in an ANSI 45/46 12-pulse configuration shifted an extra 15° apart to make a 24-pulse system. The rectifiers are equipped with a single branch harmonic filter, also at 66 kV, tuned at the 4.7<sup>th</sup> harmonic and rated at 15 MVAR effective.

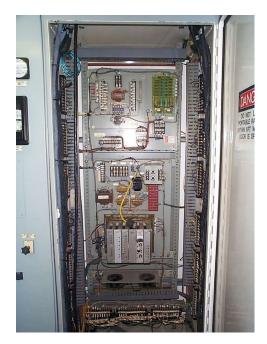
Fig. 6: Line A Rectifier Control System

The origin of the difficulties experienced is a thyristor firing circuit problem. The age of the control system and resulting electronic component "drift", appears to have created a Type 1 timing irregularity.

The Line A rectifier is over 30 years old and, while well past its original design life, continued operation of these robust machines is common in the electrochemical industry. The Achilles heal of these units is typically the aging electronics of the control system. Electronic equipment has a bathtub-shaped reliability curve and this equipment is likely on the upward slope of that curve. In short, control system problems are to be expected with older rectifiers.

The installation of a new rectifier control system is a substantial capital expenditure, and the plant is now

considering this step. In the meantime, the following measures have been put into place.

Steps have been taken to mitigate the immediate issues as noted and a replacement control system is under consideration by the plant.
